**Flood Control Project Maintenance  
Levee Inspections**

**Maintenance Issue Types Only, Levee Inspection Report By Mile - Fall 2018**

**Reclamation District No. 0563 Tyler Island**

Waterway	Bank	Unit Miles	Inspection Start/End	Inspector
Unit No. 01 Georgiana Slough (Tyler Island)	Left	12.11	10/11/2018 10/11/2018	David Julian

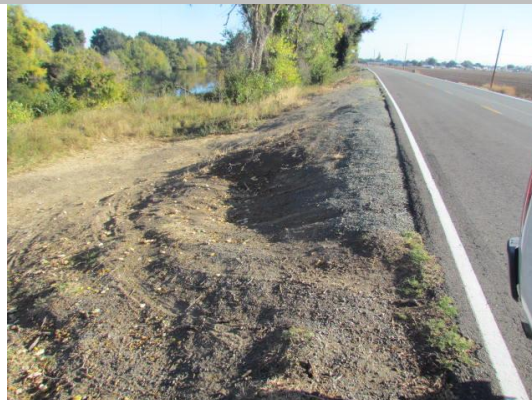
Photo 2 of 2 : FA\_2018\_RD0563\_210\_143\_20180925\_00101.jpg

LM Start	0.56	Rating **	M	Issue No.	143 (cont)	
LM End	0.56	Issue Type +	Ma	Location *	WS	
Category	Earthen Levee			GPS Latitude/Longitude		
				Start		End
Item	Slope Stability			38.228930 °	38.228930 °	
				-121.523935 °	-121.523935 °	
DWR ID	DWR_RD0563_01_f_2014_143					
Comment Code						
S3 : Repair the levee slope damaged by vehicle traffic and prevent access where possible.						
Inspector Comment						
Slope damage due to vehicle traffic.

Looking northwest at slope damage on waterward slope.

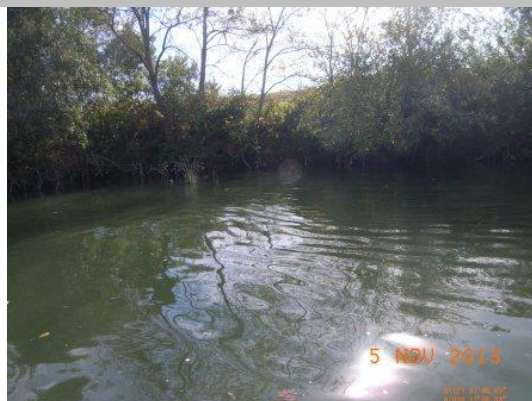
Photo 1 of 1 : FA\_2018\_RD0563\_210\_70\_20181023\_00227.jpg

LM Start	0.92	Rating **	M	Issue No.	70
LM End	1.11	Issue Type +	Ma	Location *	WS
Category	Supplemental			GPS Latitude/Longitude	
				Start	End
Item	2017 USACE Erosion Survey, DRAFT			38.225660 °	38.227157 °
				-121.527556 °	-121.530432 °
DWR ID	DWR_RD0563_01_f _ 2018_70				
Comment Code					
Inspector Comment					
2017 Site ID: GEO 11.0 L					
Status: Eroding					
2017 Field Notes: Increased toe erosion, slumping, boat wake erosion, and revetment failure near downstream end. Site extended upstream.					
Site History: 2011 - Short sections of eroding bank at the waterline and holes in toe of levee. 2012 - Site extended upstream. 2013 - Erosion pockets filled with an insufficient amounts of revetment. 2016 - Fresh erosion observed.

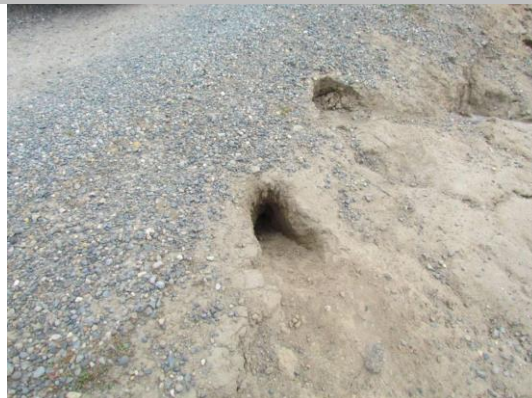
Photo 1 of 2 : FA\_2018\_RD0563\_210\_121\_20180925\_00080.jpg

Looking at typical rodent hole within this reach.

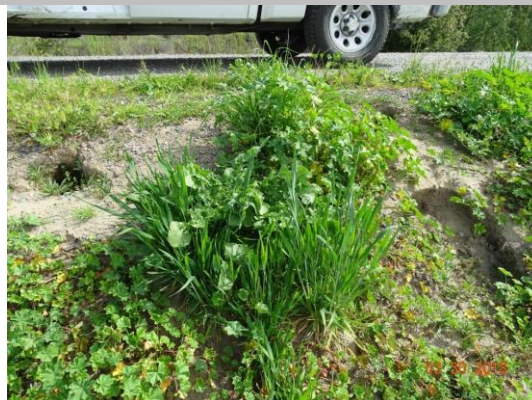
Photo 2 of 2 : FA\_2018\_RD0563\_210\_121\_20180925\_00081.jpg

3/30/2018: Rodent burrows on landside.

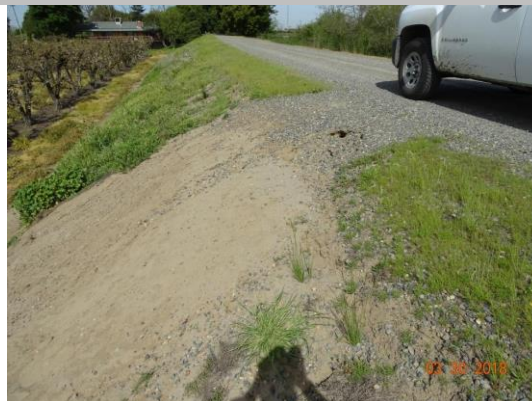
Photo 1 of 1 : FA\_2018\_RD0563\_210\_110\_20180925\_00072.jpg

LM Start	1.03	Rating **	U	Issue No.	110	
LM End	1.03	Issue Type +	Ma	Location *	LS	
Category	Earthen Levee			GPS Latitude/Longitude		
				Start		End
Item	Animal Control			38.226422 °	38.226422 °	
				-121.529410 °	-121.529410 °	
DWR ID	DWR_RD0563_01_s_2018_110					
Comment Code						
A3 : No rodents visible, but rodent burrows visible; need to backfill and compact or grout burrows.						
Inspector Comment						
Very large rodent burrow has caused landside shoulder to collapse. Shoulder should be restored.

3/30/2018: Very large rodent burrow causing caving at landside shoulder.

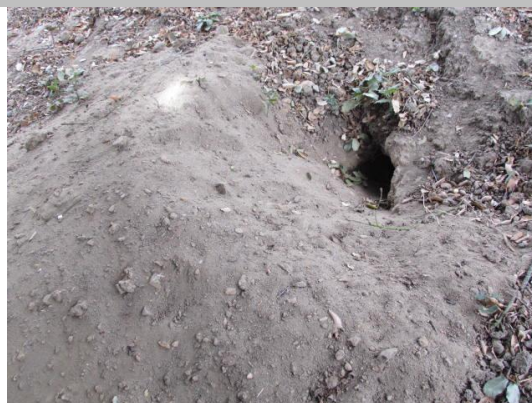
Photo 1 of 1 : FA\_2018\_RD0563\_210\_153\_20180925\_00107.jpg

LM Start	1.15	Rating **	U	Issue No.	153
LM End	1.15	Issue Type +	Ma	Location *	LS
Category	Earthen Levee			GPS Latitude/Longitude	
				Start	End
Item	Animal Control			38.226910 °	38.226910 °
				-121.531294 °	-121.531294 °
DWR ID	DWR_RD0563_01_f_2015_153				
Comment Code					
A3 : No rodents visible, but rodent burrows visible; need to backfill and compact or grout burrows.					
Inspector Comment					
Several large to medium rodent holes noted.

Looking at typical view of several rodent holes on landward slope.

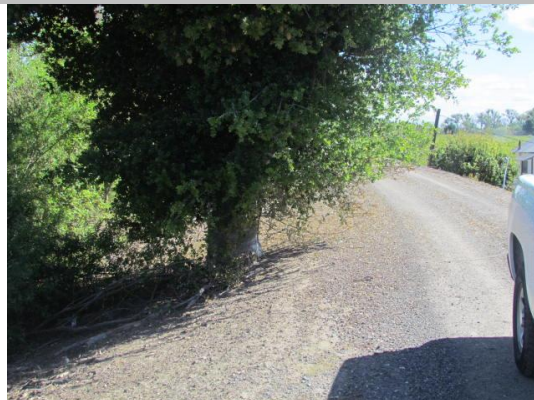
Photo 1 of 1 : FA\_2018\_RD0563\_210\_759\_20180925\_00114.jpg

Looking northwest at untrimmed trees on waterward slope and toe.

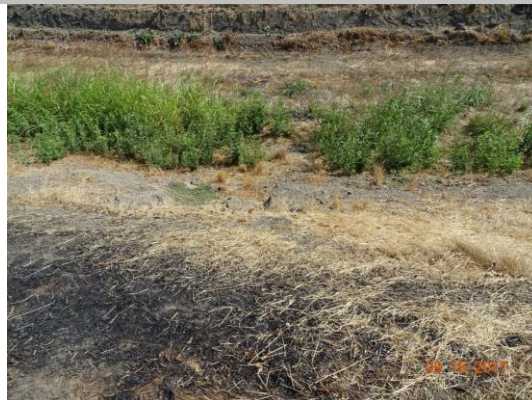
Photo 1 of 1 : FA\_2018\_RD0563\_210\_116\_20180925\_00075.jpg

LM Start	2.25	Rating **	A/W	Issue No.	116
LM End	2.25	Issue Type +	Ma	Location *	LS
Category	Earthen Levee			GPS Latitude/Longitude	
				Start	End
Item	Erosion / Bank Caving			38.217588 °	38.217588 °
				-121.542520 °	-121.542520 °
DWR ID	DWR_RD0563_01_s_2017_116				
Comment Code					
E2 : Schedule repair of erosion site prior to the next inspection.					
Inspector Comment					
LMA found the erosion while on patrol during the February Storm 2017.

Looking east at the landside toe erosion.

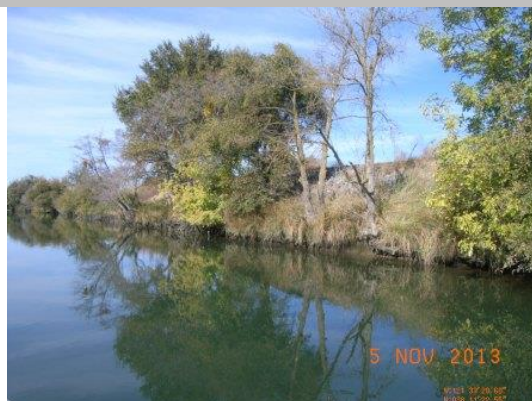
Photo 1 of 1 : FA\_2018\_RD0563\_210\_107\_20181023\_00236.jpg

2017 Site ID: GEO 9.3 L  
Status: Critical  
2017 Field Notes: Upgraded to critical. Pockets of erosion - subvertical. Areas of failed revetment, old rock is unraveling, and eminent tree popout outs expected.  
Site History: 1997 - Loss of rock at toe; pockets of upper berm erosion; very narrow berm width; toe rock problem; erosion pockets in rock. 2002 - New brush boxes at toe of the worst spots. 2005 - Upstream 200 ft removed because of the wide berm. 2006 - Some rock repair pockets behind the brush boxes at the upstream end. 2010 - Some new erosion. 2013 - New rock placed on the levee slope. 2016 - Fresh erosion along the toe.

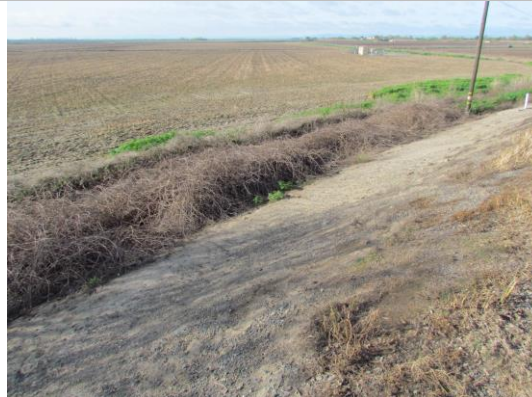
Photo 1 of 2 : FA\_2018\_RD0563\_210\_67\_20180925\_00024.jpg

Looking east at dead berryvines at landward toe. (Spring 2017)

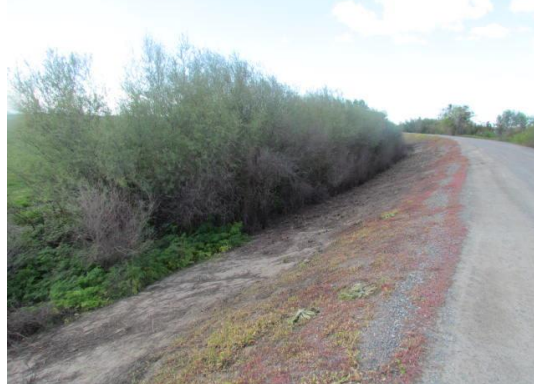
Photo 3 of 5 : FA\_2018\_RD0563\_210\_74\_20180925\_00035.jpg

Looking south at dense vegetation (willows) at landward toe. (Spring 2016)

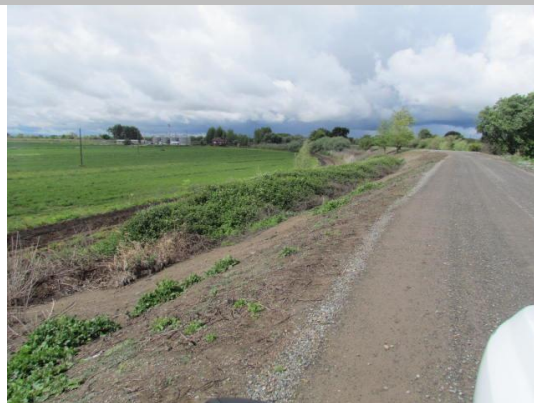
Photo 4 of 5 : FA\_2018\_RD0563\_210\_74\_20180925\_00036.jpg

Looking southeast at dense berryvines at landward toe. (Spring 2015)

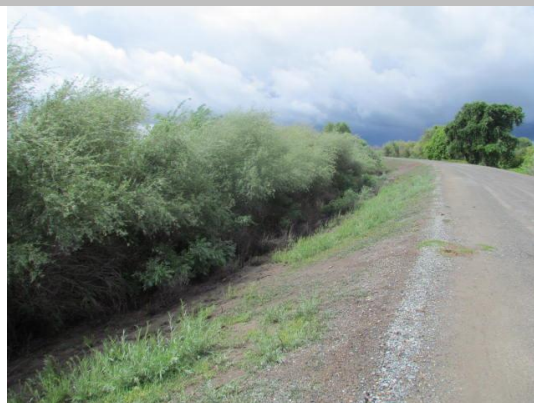
Photo 5 of 5 : FA\_2018\_RD0563\_210\_74\_20180925\_00037.jpg

Looking south at dense vegetation at landward slope and toe. (Spring 2015)

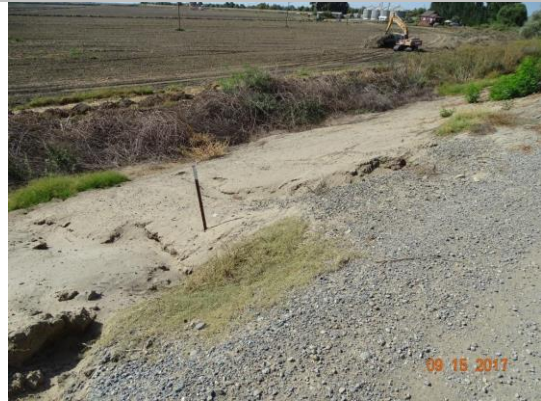
Photo 1 of 5 : FA\_2018\_RD0563\_210\_78\_20180925\_00043.jpg

LM Start	3.06	Rating **	U	Issue No.	78
LM End	3.06	Issue Type +	Ma	Location *	LS
Category	Earthen Levee			GPS Latitude/Longitude	
				Start	End
Item	Slope Stability			38.210240 °	38.210240 °
				-121.537517 °	-121.537517 °
DWR ID	DWR_RD0563_01_s_2012_78				
Comment Code					
S1 : Repair slope instability.					
Inspector Comment					
Slope damage on landside shoulder and slope has been in place for several inspection cycles. Proper drainage should be provided to prevent further erosion, and erosion should be repaired.

Looking southwest at the landside slope.

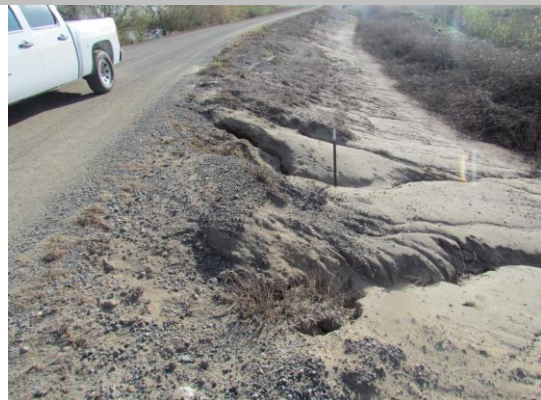
Photo 2 of 5 : FA\_2018\_RD0563\_210\_78\_20180925\_00044.jpg

Looking north at rain runoff erosion on landward slope. (Spring 2017)

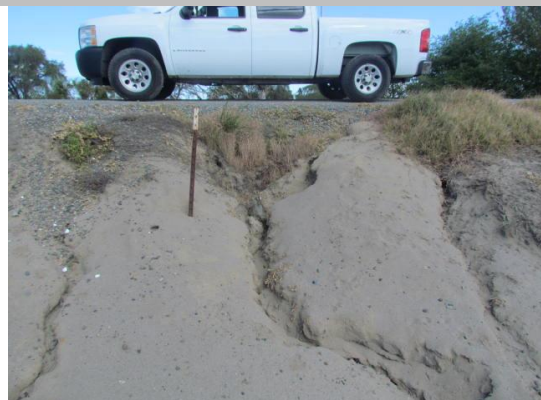
Photo 3 of 5 : FA\_2018\_RD0563\_210\_78\_20180925\_00045.jpg

Looking west at rain runoff erosion on landward slope. (Spring 2016)

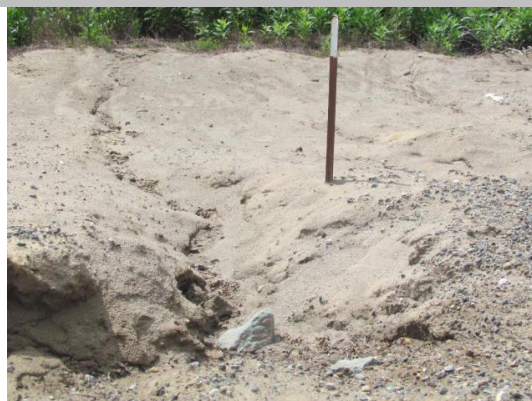
Photo 4 of 5 : FA\_2018\_RD0563\_210\_78\_20180925\_00046.jpg

LM Start	3.06	Rating **	U	Issue No.	78 (cont)	
LM End	3.06	Issue Type +	Ma	Location *	LS	
Category	Earthen Levee			GPS Latitude/Longitude		
				Start		End
Item	Slope Stability			38.210240 °		38.210240 °
				-121.537517 °		-121.537517 °
DWR ID	DWR_RD0563_01_s_2012_78					
Comment Code						
S1 : Repair slope instability.						
Inspector Comment						
Slope damage on landside shoulder and slope has been in place for several inspection cycles. Proper drainage should be provided to prevent further erosion, and erosion should be repaired.

Looking east at slope erosion. (Updated Spring 2012)

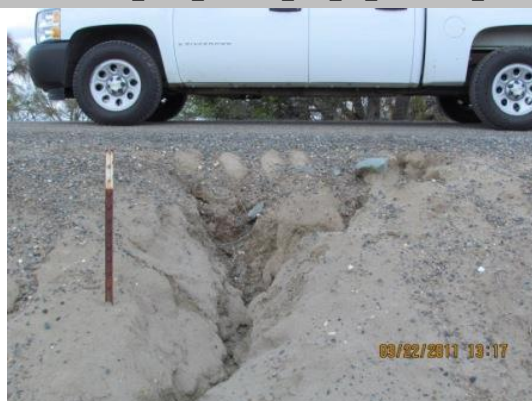
Photo 5 of 5 : FA\_2018\_RD0563\_210\_78\_20180925\_00047.jpg

Looking west at slope erosion cause by runoff on landside slope.

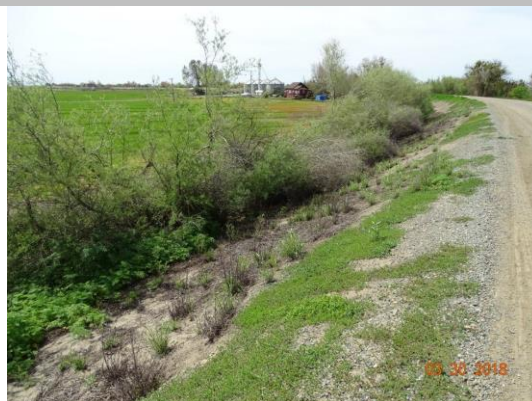
Photo 1 of 1 : FA\_2018\_RD0563\_210\_112\_20180925\_00073.jpg

LM Start	3.11	Rating **	U	Issue No.	112
LM End	3.18	Issue Type +	Ma	Location *	LS
Category	Earthen Levee			GPS Latitude/Longitude	
				Start	End
Item	Vegetation			38.210018 °	38.209495 °
				-121.538353 °	-121.539515 °
DWR ID	DWR_RD0563_01_s_2018_112				
Comment Code					
V7 : Trees / Woody Vegetation					
Inspector Comment					
Dense woody vegetation (up to 6" in diameter) along lower slope and toe prevents inspection and access. Needs to be removed.

Very dense woody vegetation preventing inspection and access to landside toe.

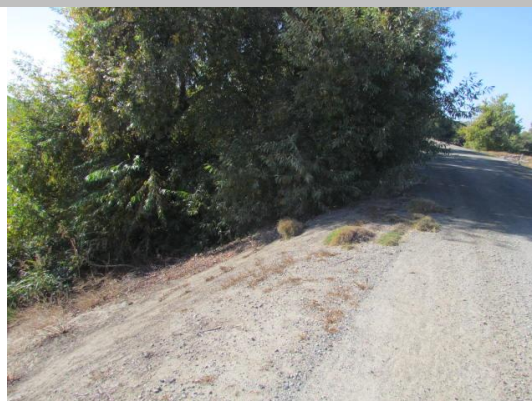
Photo 1 of 2 : FA\_2018\_RD0563\_210\_68\_20180925\_00026.jpg

Looking south at dense trees on landward slope.

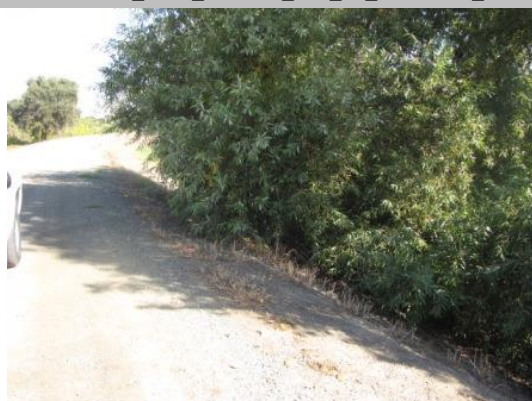
Photo 2 of 2 : FA\_2018\_RD0563\_210\_68\_20180925\_00027.jpg

Looking southeast at dense trees on landside slope and toe.

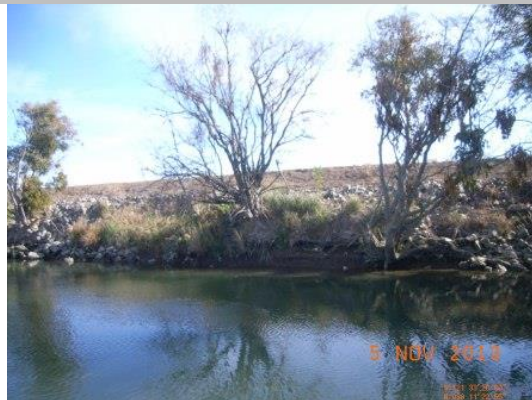
Photo 1 of 1 : FA\_2018\_RD0563\_210\_94\_20181023\_00235.jpg

LM Start	3.42	Rating **	M	Issue No.	94
LM End	4.01	Issue Type +	Ma	Location *	WS
Category	Supplemental			GPS Latitude/Longitude	
				Start	End
Item	2017 USACE Erosion Survey, DRAFT			38.206346 °	38.199925 °
				-121.540819 °	-121.544249 °
DWR ID	DWR_RD0563_01_f _ 2018_94				
Comment Code					
Inspector Comment					
2017 Site ID: GEO 8.3 L					
Status: Eroding					
2017 Field Notes: New rock on levee in sections, failure of old rock in other sections, site extended upstream to account for new erosion pocket.					
Site History: 1997 - Narrow eroding berm upstream of existing rock.					
2001 - Staked, low fascine walls at bankline. 2011 - Minor new erosion. Site extended downstream. 2012 - Rock repair failing in one erosion pocket. 2016 - Fresh erosion observed.

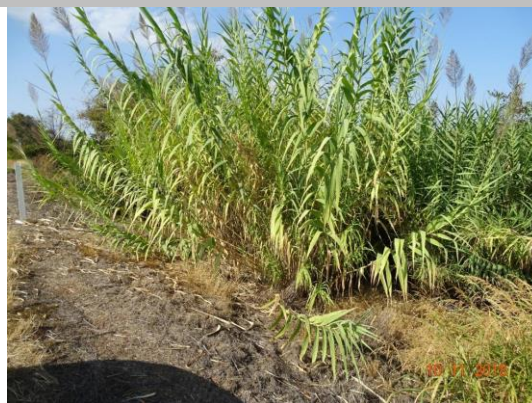
Photo 1 of 1 : FA\_2018\_RD0563\_210\_146\_20181012\_00225.jpg

View of arundo on waterside slope (October 2018).

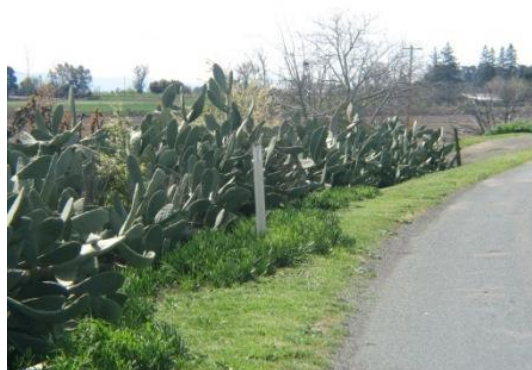
Photo 1 of 2 : FA\_2018\_RD0563\_210\_22\_20180925\_00010.jpg

Large cactus plant on landward slope from LM 6.04 to 6.08

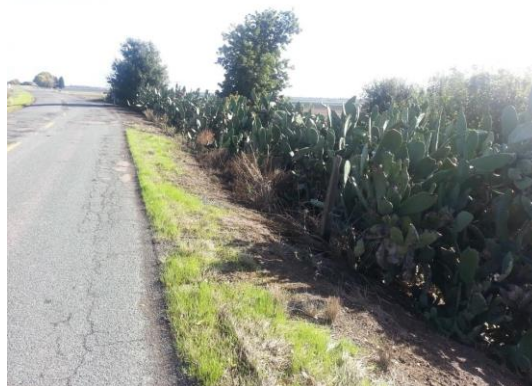
Photo 2 of 2 : FA\_2018\_RD0563\_210\_22\_20180925\_00011.jpg

Looking downstream at dense cactus on landward slope. (Fall 2016)

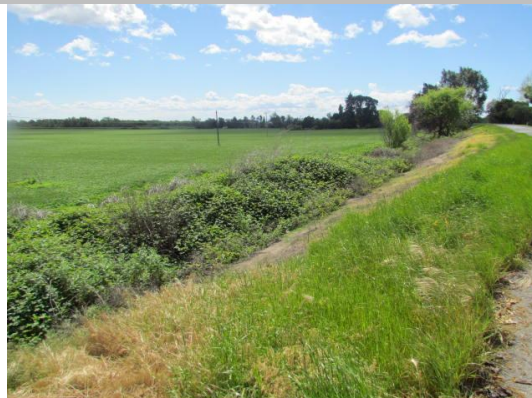
Photo 1 of 1 : FA\_2018\_RD0563\_210\_164\_20180925\_00110.jpg

Looking east at dense vegetation (vines) at landward toe.

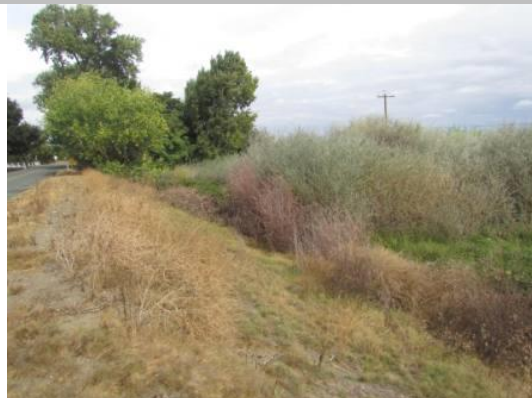
Photo 2 of 3 : FA\_2018\_RD0563\_210\_90\_20180925\_00054.jpg

Looking northeast at dense vegetation on landside toe.

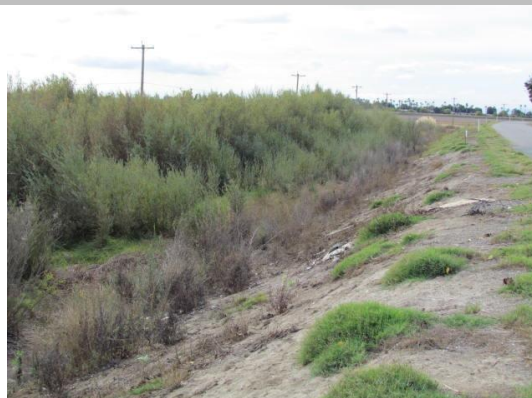
Photo 3 of 3 : FA\_2018\_RD0563\_210\_90\_20180925\_00055.jpg

Looking south at dense vegetation on landside toe. (2012 Fall Inspection)

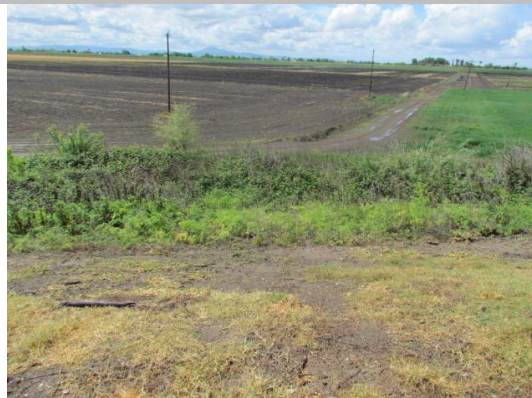
Photo 1 of 1 : FA\_2018\_RD0563\_210\_769\_20180925\_00120.jpg

Looking east at dense vegetation at landward toe. (Spring 2015)

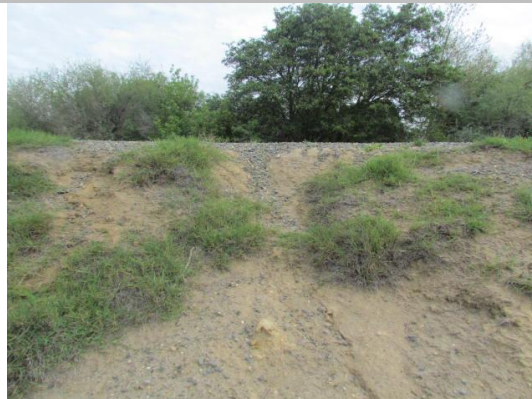
Photo 1 of 2 : FA\_2018\_RD0563\_210\_99\_20180925\_00062.jpg

Looking west at minor erosion on landward shoulder and slope.

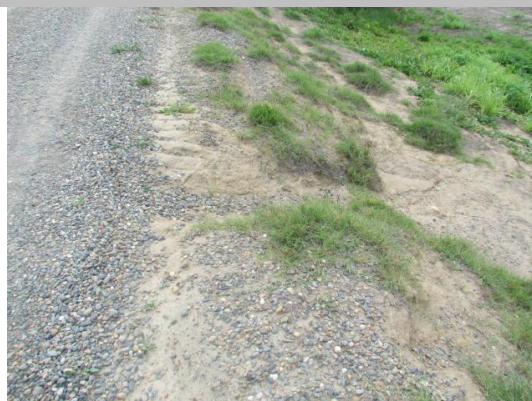
Photo 2 of 2 : FA\_2018\_RD0563\_210\_99\_20180925\_00063.jpg

Looking north at minor erosion on landward shoulder and slope.

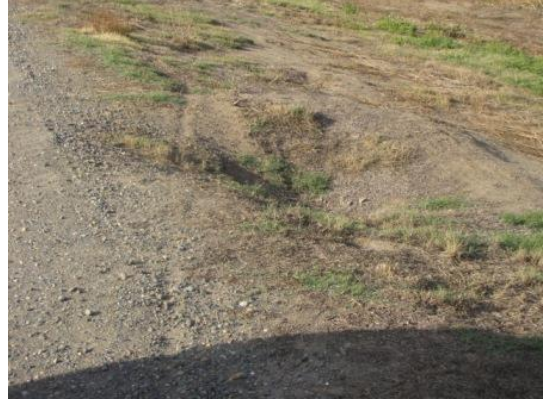
Photo 1 of 4 : FA\_2018\_RD0563\_210\_76\_20180925\_00039.jpg

Looking northeast a depression on landside shoulder and slope above 10" irrigation pipe four feet below crown.

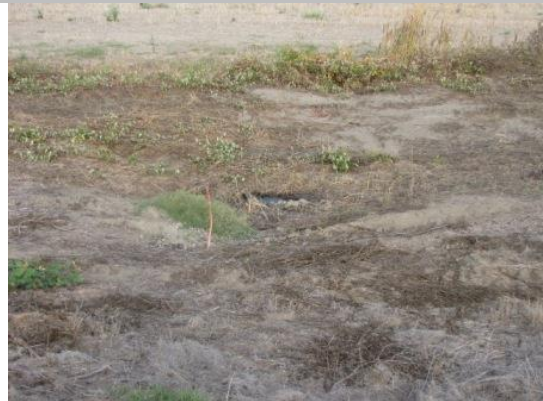
Photo 2 of 4 : FA\_2018\_RD0563\_210\_76\_20180925\_00040.jpg

Looking east at water ponding at landside toe just above 10" irrigation pipe.

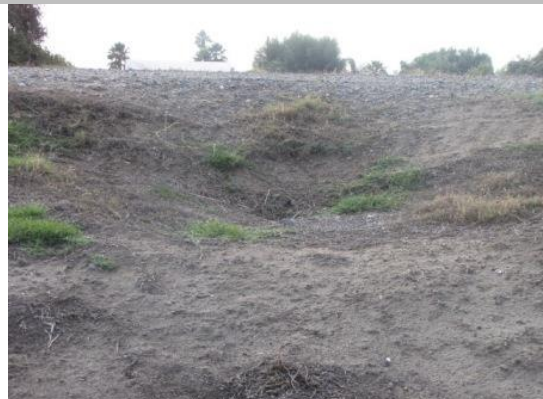
Photo 3 of 4 : FA\_2018\_RD0563\_210\_76\_20180925\_00041.jpg

Looking west at depression on landside shoulder and slope from landside toe.

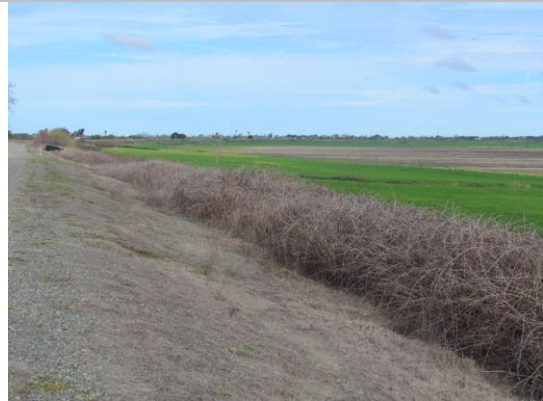
Photo 2 of 3 : FA\_2018\_RD0563\_210\_770\_20180925\_00122.jpg

Looking northeast at dead vines at landward toe. (Spring 2017)

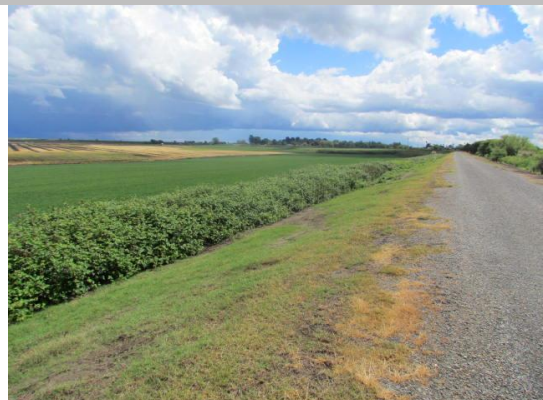
Photo 3 of 3 : FA\_2018\_RD0563\_210\_770\_20180925\_00123.jpg

Looking southeast at dense vegetation at landward toe. (Spring 2015)

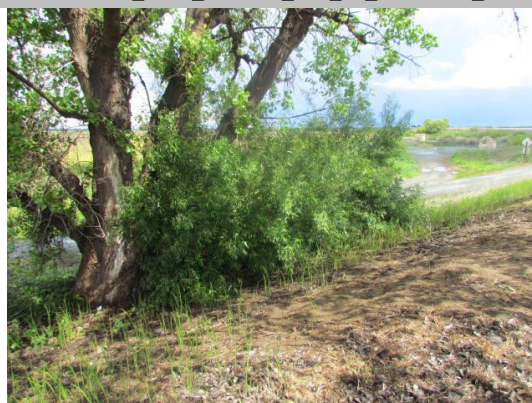
Photo 2 of 2 : FA\_2018\_RD0563\_210\_47\_20180925\_00020.jpg

Looking northeast at untrimmed tree at landward slope. (Spring 2015)
